Use of a Ground-Coupled Monostatic antenna for Determining Deterioration of Concrete Structures

Doria L. Kutrubes
Radar Solutions International
51 Riverview Avenue, Waltham, MA 02453-3819
radar@world.std.com

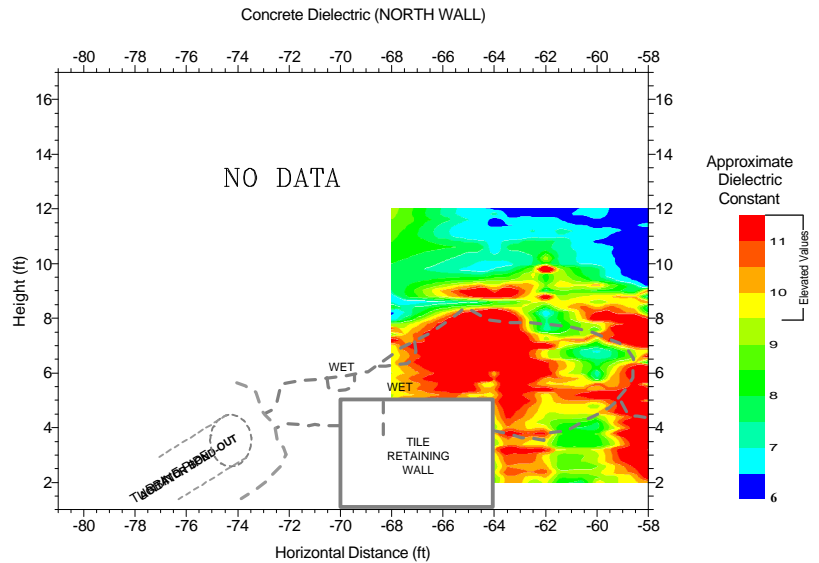
Figure 3: Approximate dielectric constant (real permittivity) measurements along accessible sections of the north wall. Note the correlation of high dielectric values with staining on the wall.

Calculated dielectric constant values of the concrete are presented on Figure 3. Upon comparing Figures 2 and 3, GPR data, not surprisingly, indicate a strong correlation between the amount of staining and moisture at the concrete surface and elevated dielectric constant values. Some elevated dielectric values are also attributed to deteriorated concrete and grouting. High dielectric values were also observed immediately above cracked areas, such as between Lines 67N and 63N, around 9 feet in elevation, and from 61N through 58N between 7 and 8 feet, and may indicate that deterioration has not yet manifested itself by surface cracking or slaying.

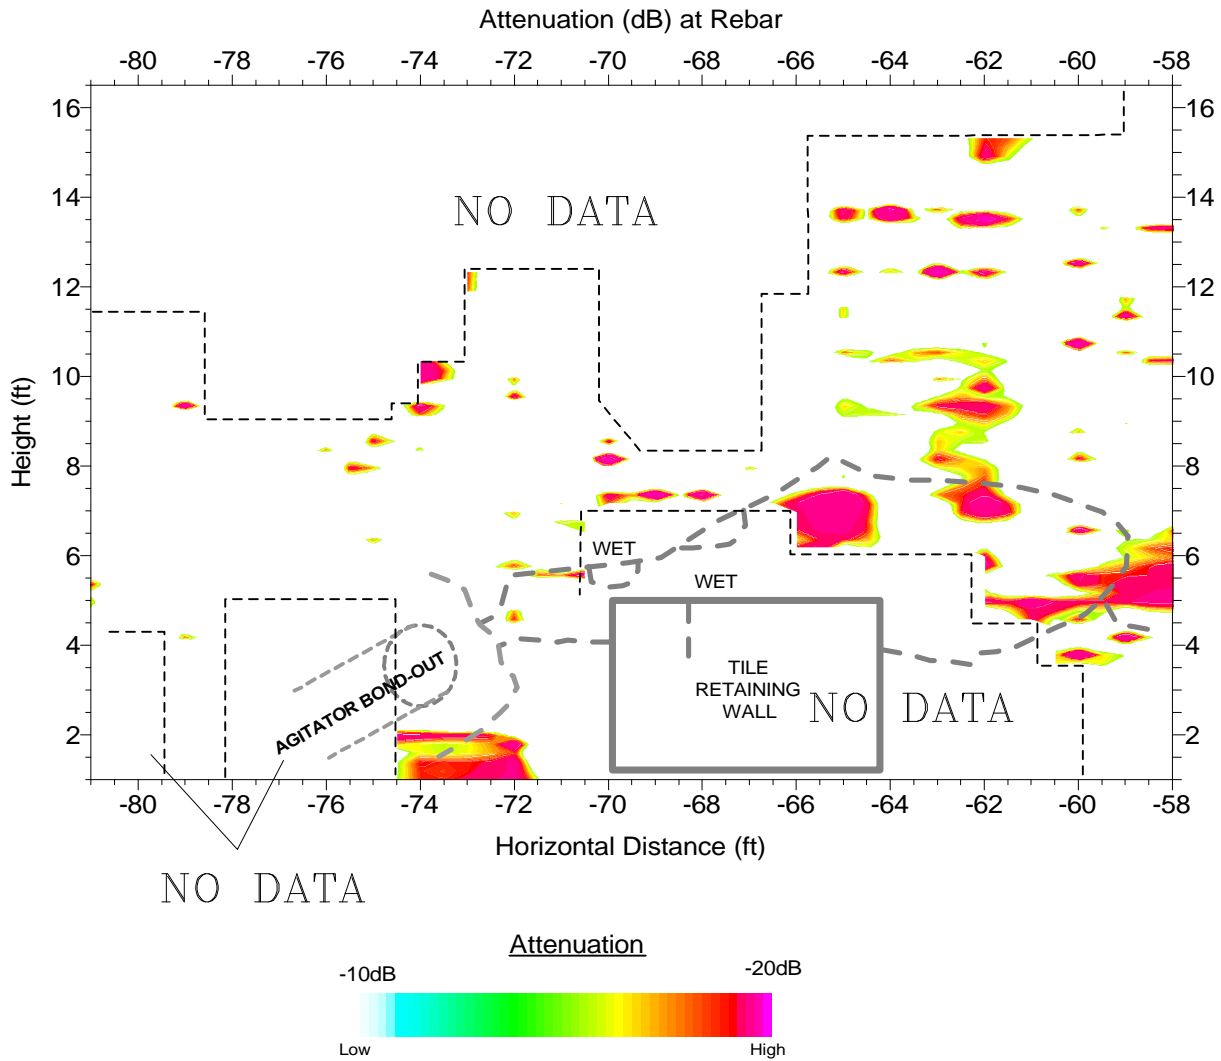
Figures 4 and 5 show deterioration at the rebar schedule and at the base of the concrete, as manifested by GPR signal attenuation. Numerous GPR anomalies consistent with delamination above (Figure 4) and below (Figure 5) the rebar schedule were observed along North Wall survey lines. The majority of GPR anomalies were observed between Lines 58N and 77N, although pipes, stairs, and other aboveground obstacles prevented full GPR coverage and created artifacts in the data. Also note that artifacts in the data may also be created by the unevenly spaced rebar (Figure 4). Some of the anomalous GPR readings could also be attributed to grouting, which conducted between Lines 58N through 72N.

Figure 4: Deteriorated concrete, as measured at the rebar schedule. Note that some artifacts may have been generated in the data from the irregularly spaced

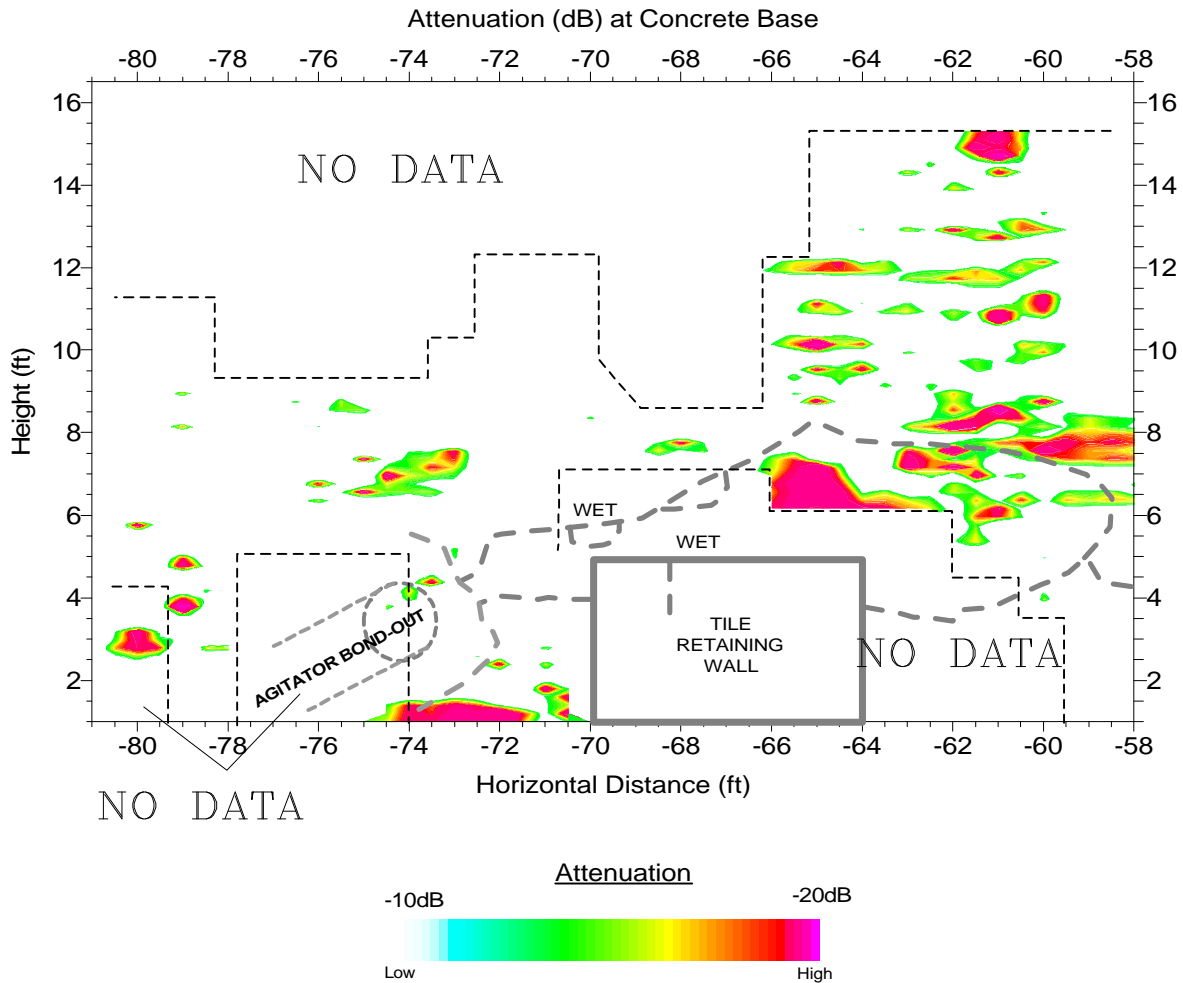
Figure 5 maps the attenuation at the concrete bottom. Nominally, the amount of calculated deterioration at the bottom of concrete is about the same as at the rebar. Some of the attenuation, however, is attributed to grout, which was injected in to the concrete near the junction of the west wall. Nevertheless, deterioration throughout the concrete wall is more significant between Lines 58N and 66N, although significant areas of deterioration were also observed above the retaining wall, from 68N to 70N and near the agitator bond out. It should also be noted that rebar was not observed in proximity of the agitator bond out, which may be the reason deterioration is more significant there.

Figure 5: Concrete deterioration as determined at bottom of concrete.
